Technical Report ARAEW-TR-06012

Analysis of HEMCL Railgun Insulator Damage

JUNE 2006

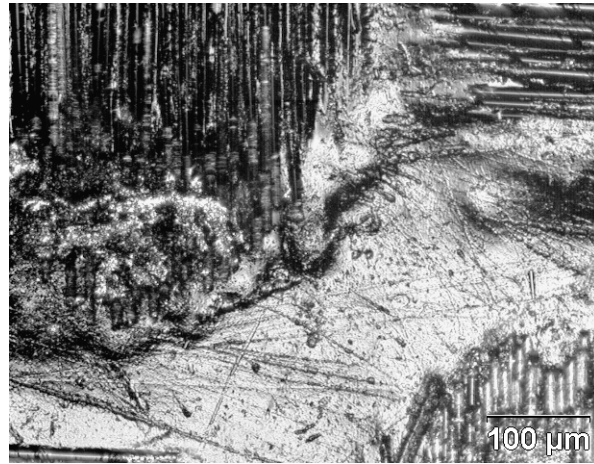
polished surface in 3b is consistent with a wax decomposition product, so we will describe it in those terms in the remainder of this report.

Figure 4. Micrograph of exposed G10 surface after gentle cleaning with an alcohol moistened cotton swab.

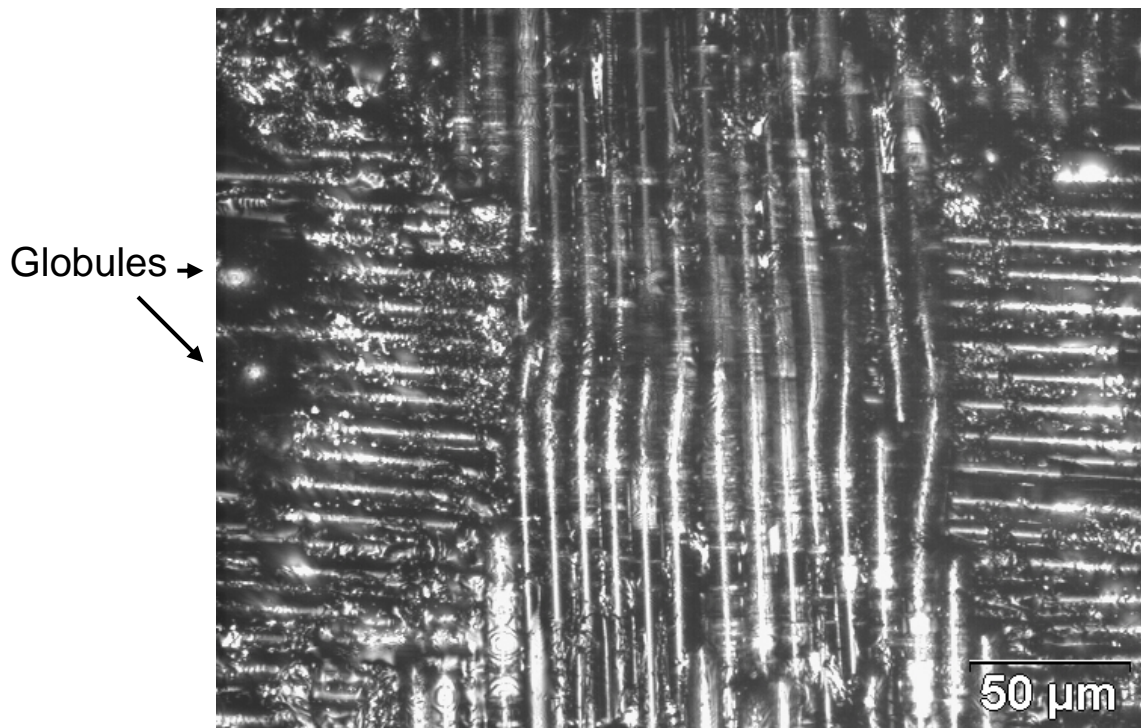
Laser pulsing also produces softening, deformation of fibers, and preferential melting of the glass fiber tips as observed in the fired specimens. See Figure 9. The softened tips exhibit rounding; at incident

laser energies of 0.3J/mm^2 and higher, there is obvious heating well above T_g , as indicated by the formation of glass globules (liquification) at the fiber tips. These glass globules are not observed in the fired specimen (Figure 8); the absence of globules in the fired specimen is likely due to the presence of high rate air flow in a railgun.

Figure 9. Micrograph of G10 insulator surface exposed to laser pulse heating of 0.3 J/mm^2 . Note softening and deformation of glass fibers and the formation of glass globules as a result of liquification of the fiber tips.

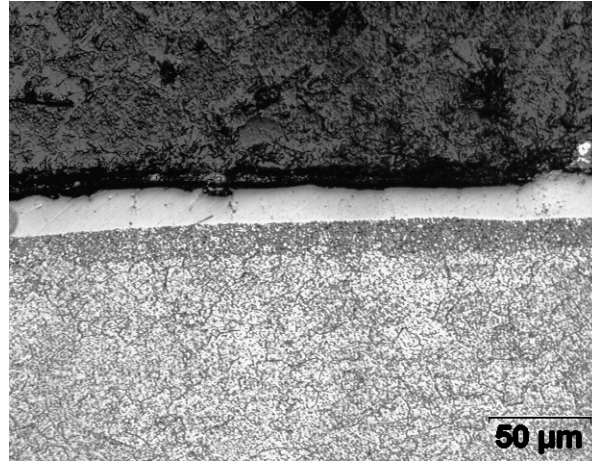
Figure 11 is a micrograph showing the cross section of the steel liner at the 122 cm location which is approximately 30 cm downbore from the Glidcop/steel joint. So it is located at roughly the center of the 0.7 meter insulator specimen in this study. It shows a steel melt layer of approximately 20 microns thickness with an associated heat affected zone (HAZ) of approximately the same thickness. This damage was produced with a single shot and is typical of the entire steel surface. No edge groove is detectable, presumably because only a single shot was fired. This uniform heating cannot be attributed to joule heating from current flow through the rails and armature because that current is known to be localized at the top and bottom edges of the conductors [2].

Data on the steel liner surface show a similar uniform heating damage over the entire surface of the steel. The relative uniformity of the steel surface melting and heat affected zone is inconsistent with damage from current flow through the conductors because that current is known to be localized at the top and bottom edges of the rails and armatures[2].

Figure 11. Micrograph showing typical severe thermal damage to the surface of the steel liner adjacent to the 0.7 meter insulator specimen. This damage resulted from a single shot of the HEMCL railgun.
